INSPECTION

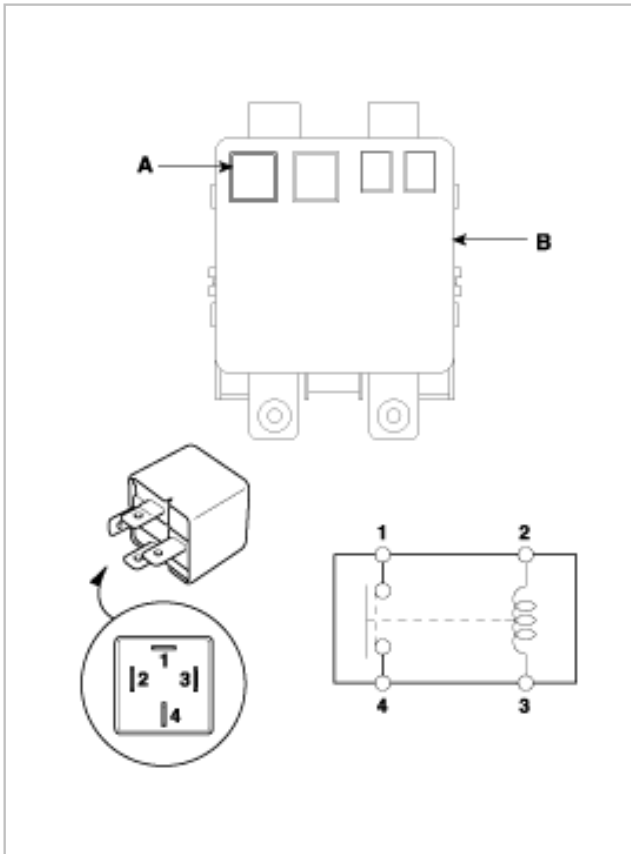
1. Remove the rear window defogger relay(A) from the passenger compartment junction block(B).
2. There should be continuity between the No.1 and No.4 terminals when power and ground are connected to the No.3 and No.2 terminals.
3. There should be no continuity between the No.1 and No.4 terminals when power is disconnected.

Terminal	2	3	1	4
Power (No.2-No.3)				
Disconnected	○ — ○			
Connected	○ — ⊕		○ — ○
